## **2-7 Water Quality Survey on Heavy Metal Pollution from Waste Disposal Facilities in Pacific Countries**

Hideaki NAGARE

*Graduate school of Environmental Science, Okayama University, Japan*

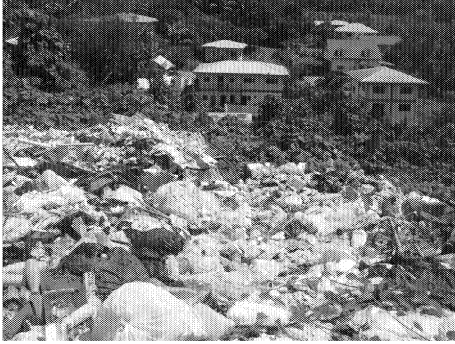
The site in Airai is always open for residents, so they can access to withdraw their waste anytime. Since segregation of waste is not common yet in the country, various kinds of stuff are intermingled together at the site. However, plastics including bag and bottles are the major stuff. Impermeable sheet is not settled underground.

Fig. 1 Dumping site in Airai state

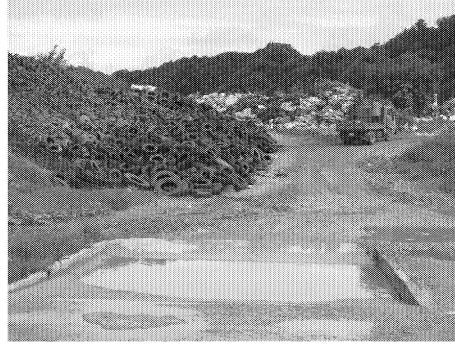
Fig. 2 Dumping site in Koror state

Another dumping site is located in Koror which is the largest state in Palau. This is the controlled type dumping site, in which some of the effluent is collected into oxidation ponds to be treated through drainage trench in underground. The treated water is dispersed at the surface of the site. This site is located by the sea, and there is no river accepting the effluent.

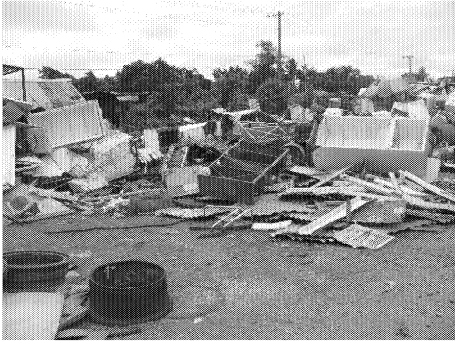
Fig. 3 Segregation in Koror site

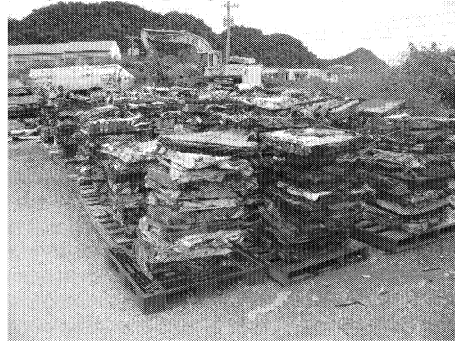
Fig. 4 Segregation in Koror site

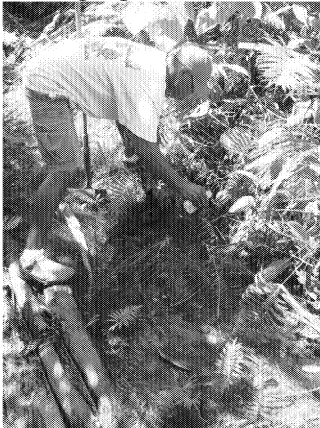
Fig. 5 Sampling at the hillside of Airai site

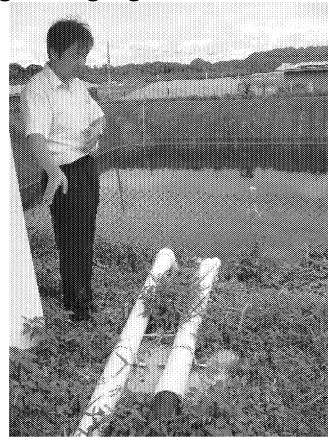
Fig. 6 Oxidation pond in Koror site

At every observation point and for every water quality item no critical concentration causing health and environmental problems was determined. Even the oxidation pond in Koror state dumping site showed EC of at most 660 (August) to 1130  $\mu$ S/cm (January).

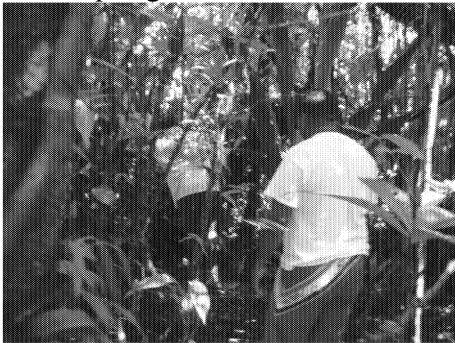
Fig. 7 Sampling in the downstream of Airai site

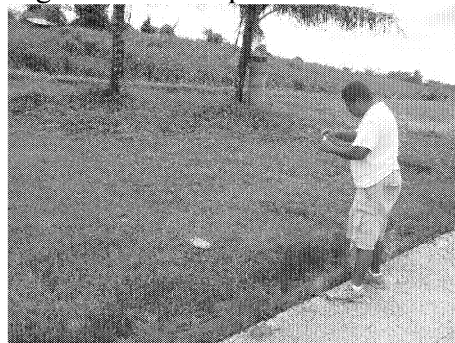
Fig. 8 Sampling at near the Koror site

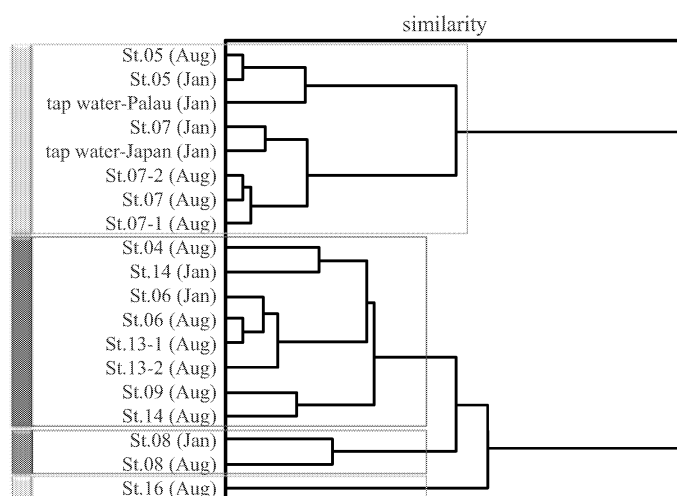
ate the similarity between the sampling points. Figure 9 shows the result indicating the similarity. As shown the figure those points were separated into four groups.

Figure 9 Dendrogram derived as the result of cluster analysis showing water quality similarity between sampling points of the water quality survey.

Point #4 is inside the Airai dumping site where stream water was taken, while the sample of the oxidation pond in Koror site was derived at point #14. Those two sampling points were obviously the effluent from the dumping sites, and were both categorized in the second group. This means those sampling points in the second group had the water quality like the effluents. The group includes the hillside of Airai dumping site shown in Figure 5, and also the puddles at the bank of Koror site in Figure 8. As those two points are adjacent to the dumping sites, it was thought that effluent from the dumping site leaked out to the surface as leachate.
